Fatal Multi-Vehicle Crash
January 5, 2020
T86.1 Westbound

After Action Review

Report

Prepared For: Pennsylvania Turnpike Commission
May 21, 2020

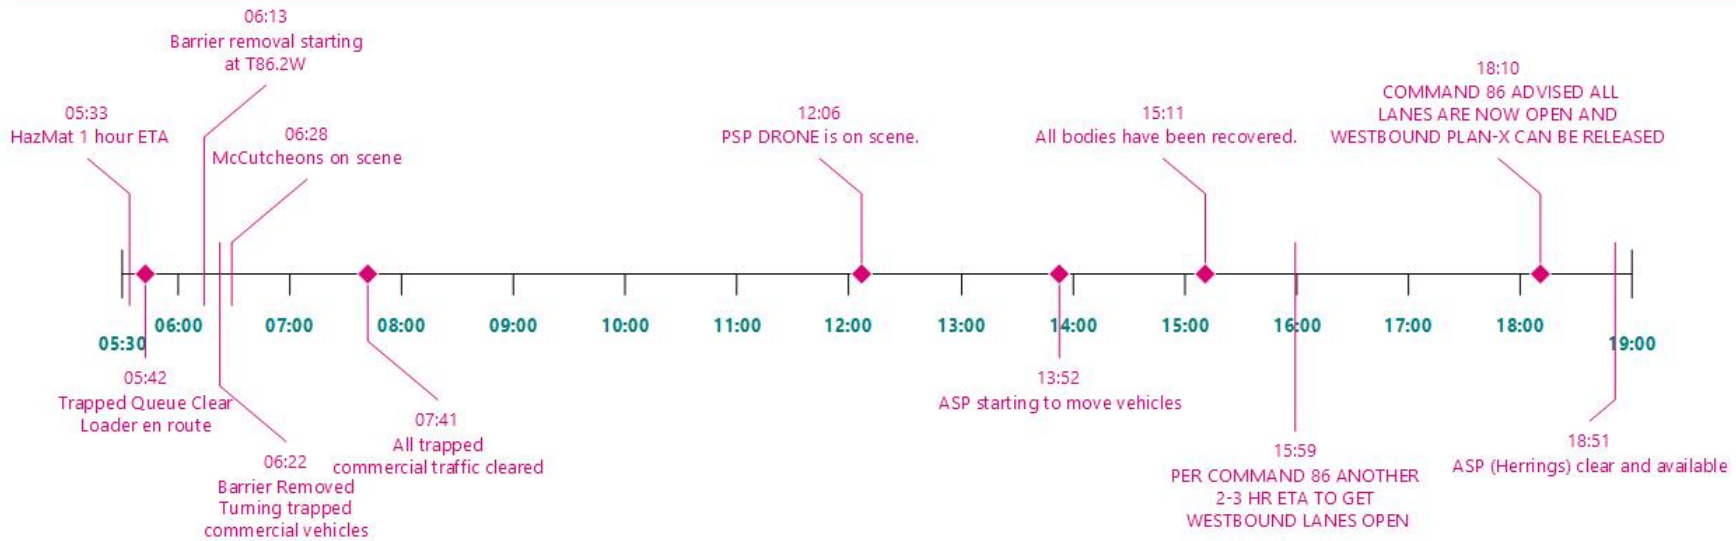
Figure 1 - Incident Timeline with Key Milestones (Westbound)

T86.1 Westbound Fatal Crash Timeline

The National Transportation Safety Board continues to investigate this crash, and as of the date of this report a formal NTSB report is still pending. **Figure 1** and **Figure 2** on pages 3 and 4 illustrate the overall incident timeline and highlights key milestone events.

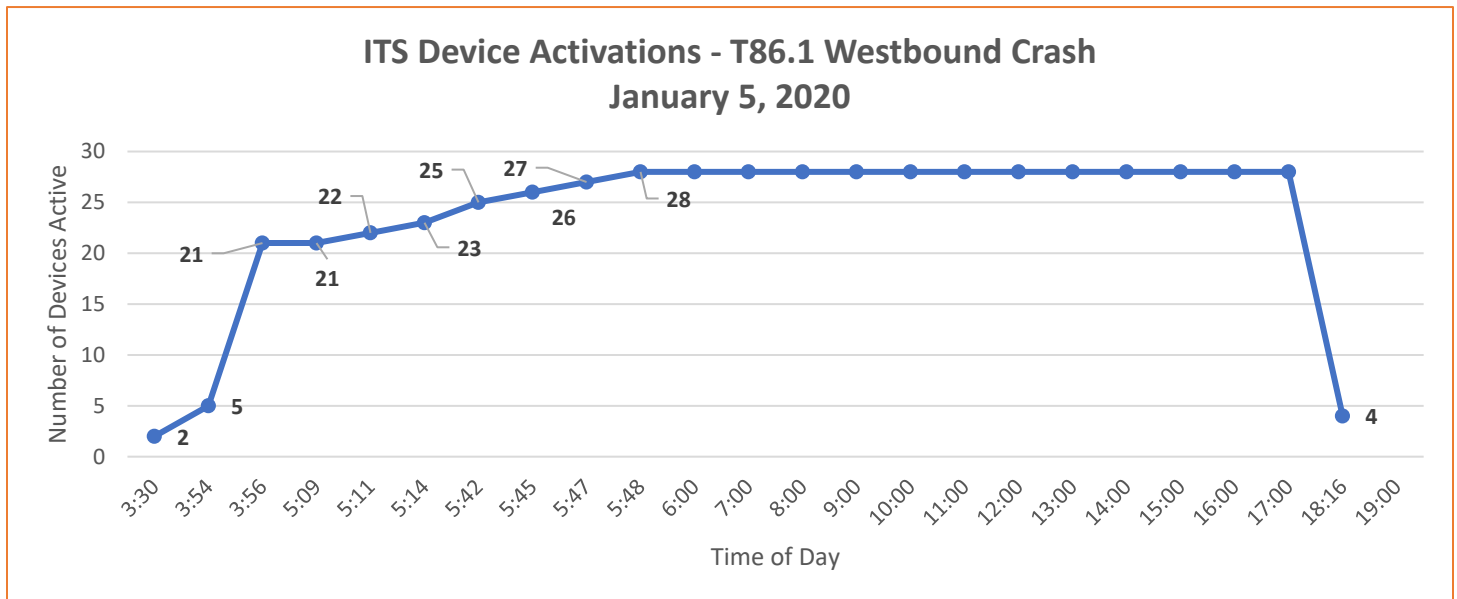
Figure 3 - ITS Device Activations

Upon initial dispatch for the crash, staff at the PA Turnpike Traffic Operations Center (TOC) took immediate action to notify motorists utilizing various ITS devices including Dynamic Message Signs (DMS) and Highway Advisory Radio (HAR). Use of these devices expanded significantly commensurate with increased situational awareness regarding the scale and severity of the incident. **Figure 3** below shows the progression and expansion of ITS device usage from the time of incident detection to roadway clearance.
