Eastbound I-94 @ Metro Parkway

Macomb County

Event Statistics

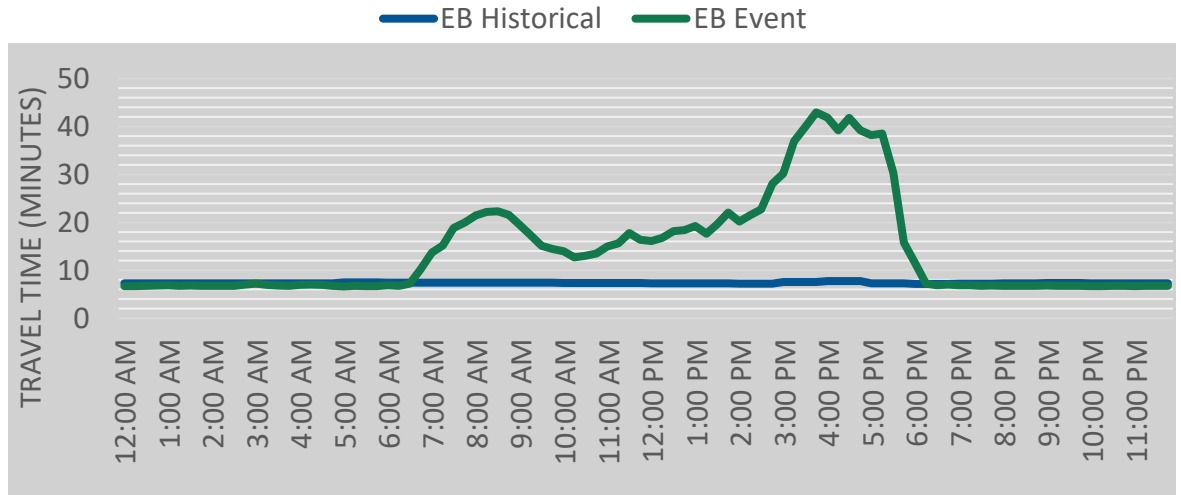
Eastbound

Travel Time

The event started at 6:35 AM causing extensive backups that dramatically increased around 3:45 PM as the cleanup intensified and afternoon rush increased volume in the area. Traffic lanes reopened at 5:24 PM with traffic flow returning to normal at 6:14 PM.
